THEHANFORDSITE

Tank B-109 Leak Assessment

Karthik Subramanian
Washington River Protection Solutions

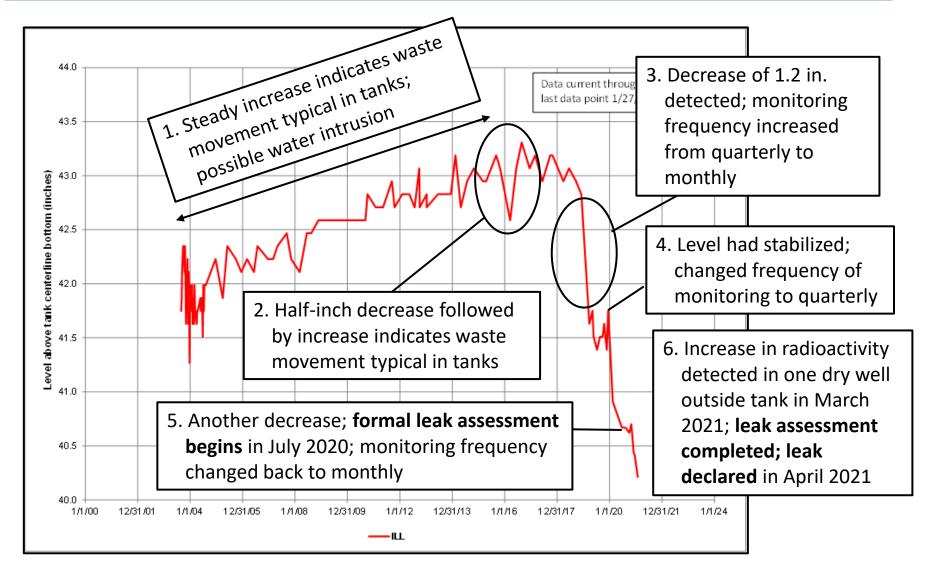
Technical Expert Interpretation of Waste Level Chart in Report

- Tank dimensions
 - 75-foot diameter tank
 - 2,750 gallons per inch of increase/decrease in waste level
- B-109 solid waste is 41% sludge, 59% saltcake
- Estimate of 3,100 total gallons leaked based on calculations from visual observations and measurements of liquid level in saltcake, sludge

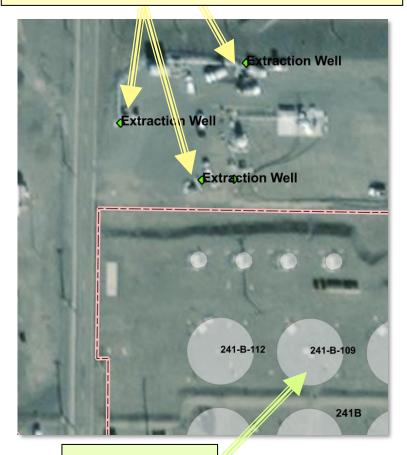
Tank B-109

Groundwater treatment system includes three nearby extraction wells

- Groundwater treatment system pumping 6 million gallons/month; capturing, removing contamination
- System installed years ago to mitigate contamination under and near B Farm from past operations
 - 52 million gallons of contaminated liquids discharged to soil disposal sites
 - 360,000 gallons of contaminated liquids from past leaks from multiple tanks in B, BX, BY farms
- Estimate at least 25 years until liquid from B-109 reaches groundwater, which is 210-240 feet below the tank
